Manhole Inspection Summary

Manhole # S35I__033MH

Insp Date: **11/4/08 12:02 PM**

Location Address: **100 s calvert st**

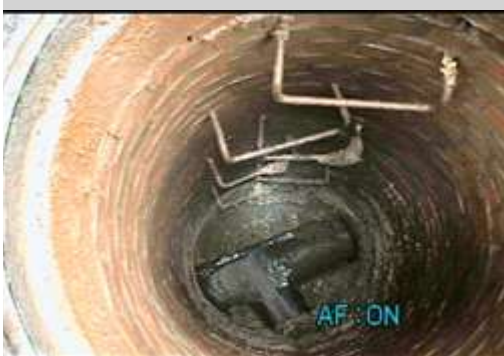
Defect 1

Count: **7** Missing: **0** ☒ **Corroded**

corr steps

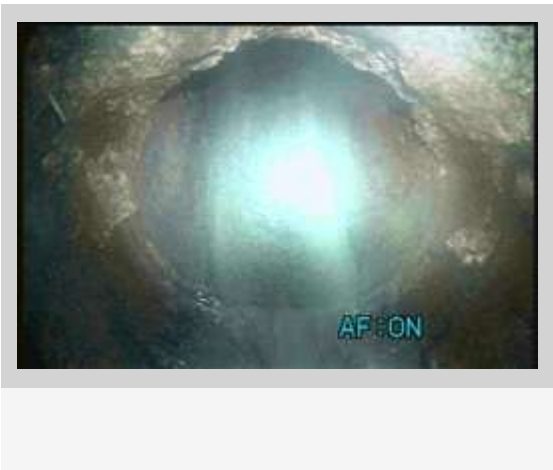
Drop In @ 9 OClock

Drop: Outside	Direct
Angled:	Reading: 0.00 (ft.)
	Inv Depth: 12.25 (ft.)
Drop Condition: Open	
Connects To: Connecting Node Not Available	
<input type="checkbox"/> Possible Illicit Connection
